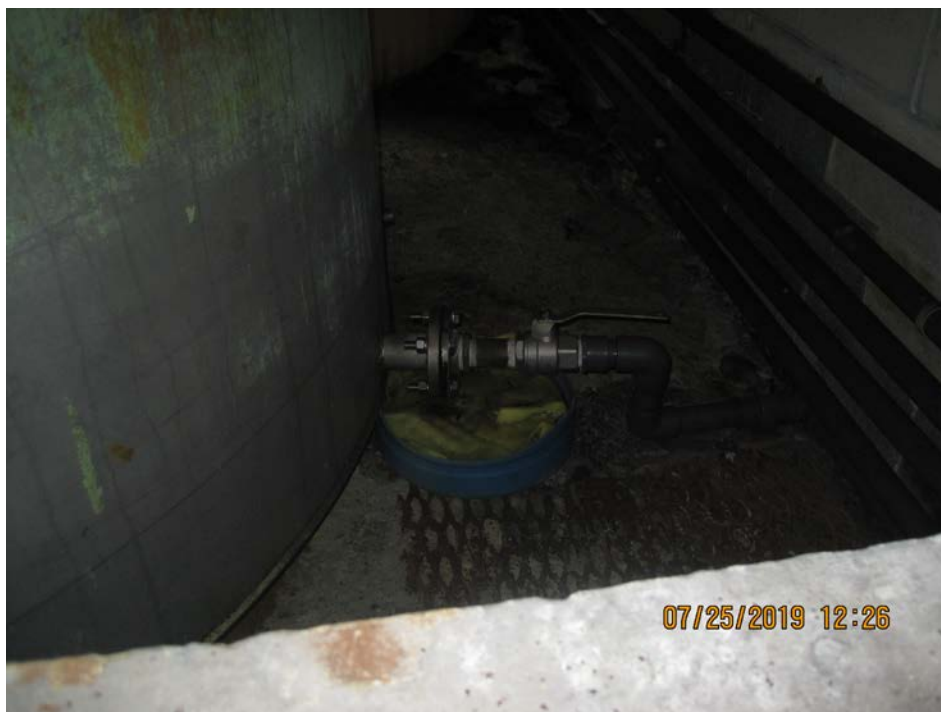
Photograph 1 – Gasket on the nitric acid tank

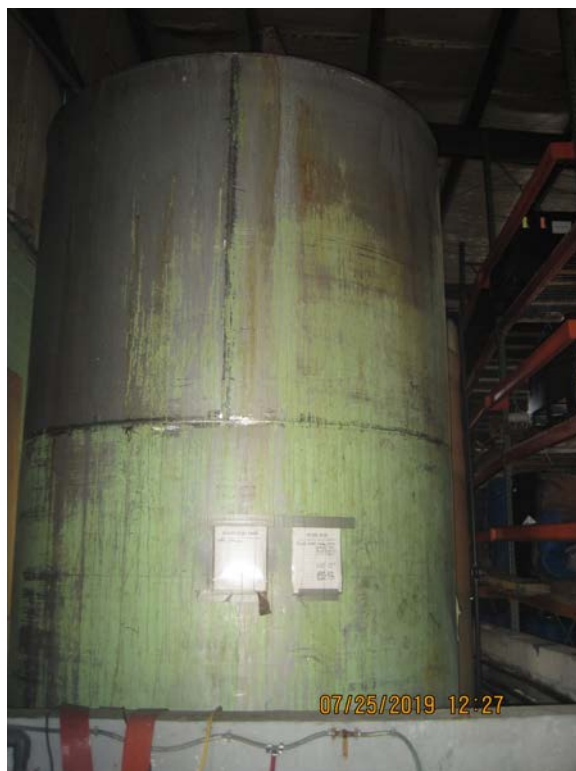
Photograph 2 – Nitric acid tank

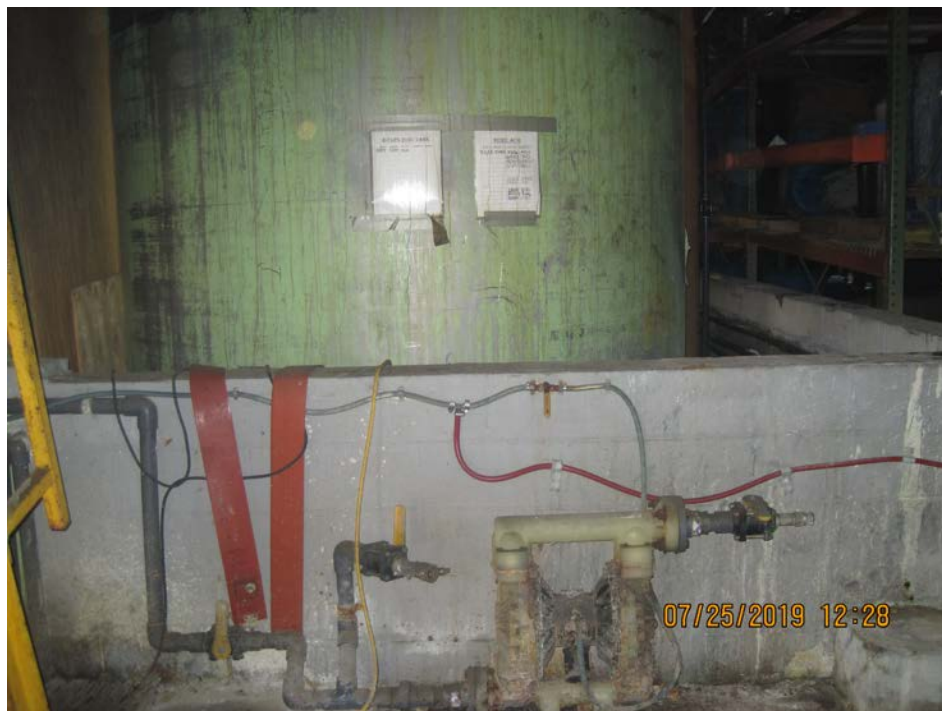
Photograph 3 – Nitric acid tank showing the containment area

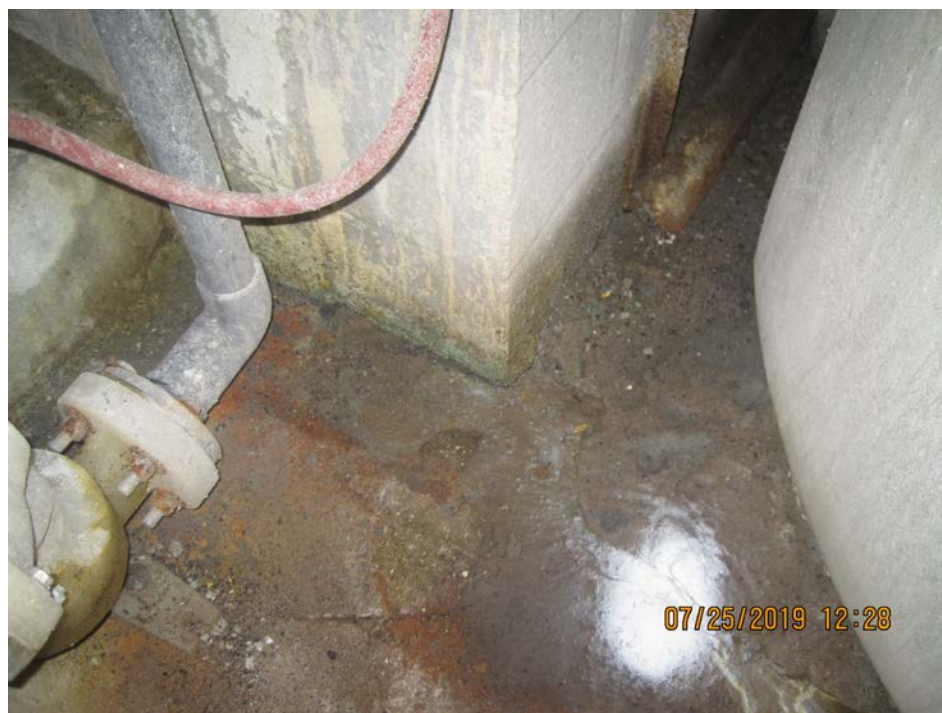
Photograph 4 – Breach in the containment area that puddled in the warehouse and exited the building

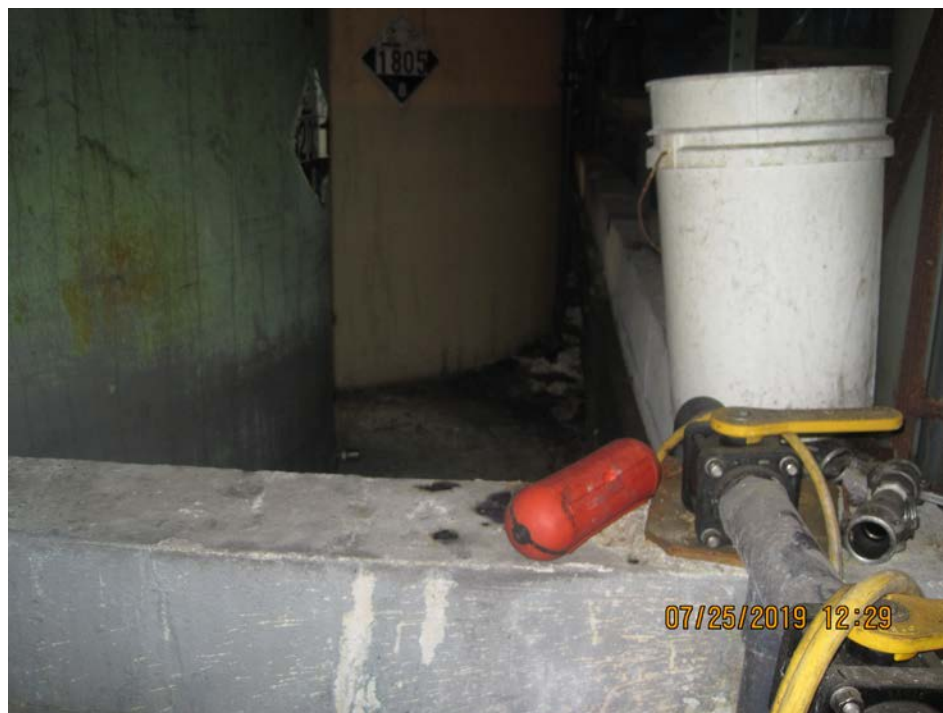
Photograph 5 – Nitric acid traveled along the inside of the containment area

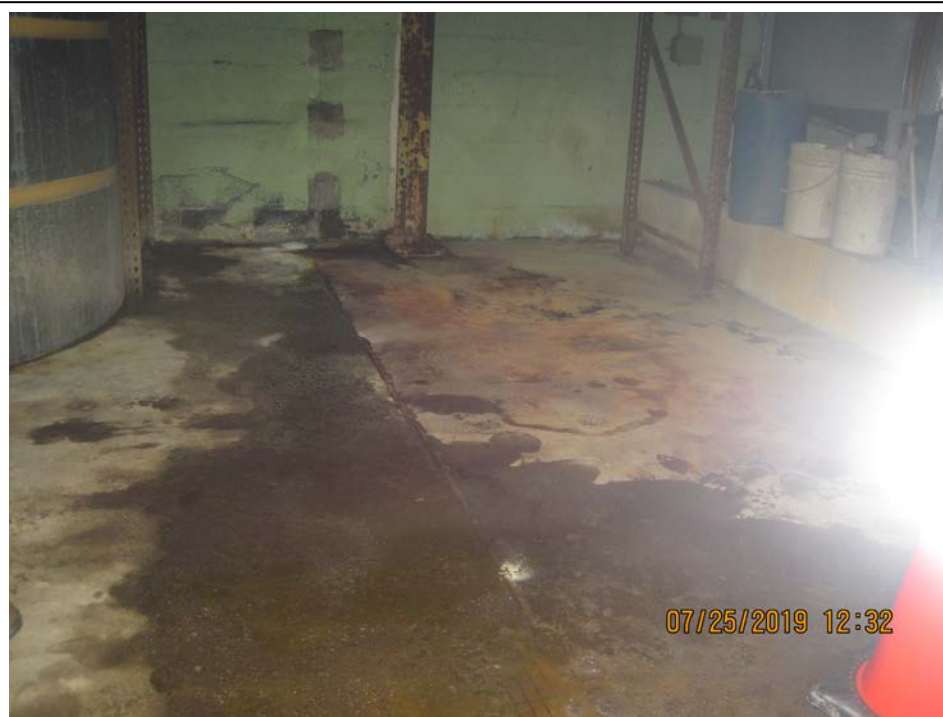
Photograph 6 – Path of the nitric acid release from the breach in the containment area to the exterior wall

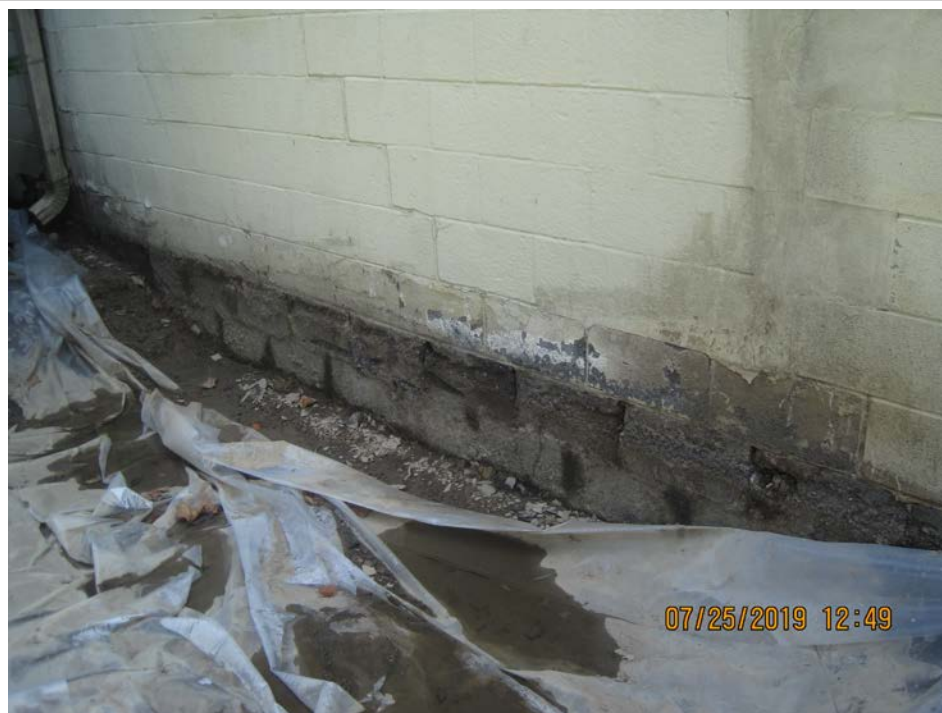
Photograph 12 – Area on the exterior wall of the building where the nitric acid was released

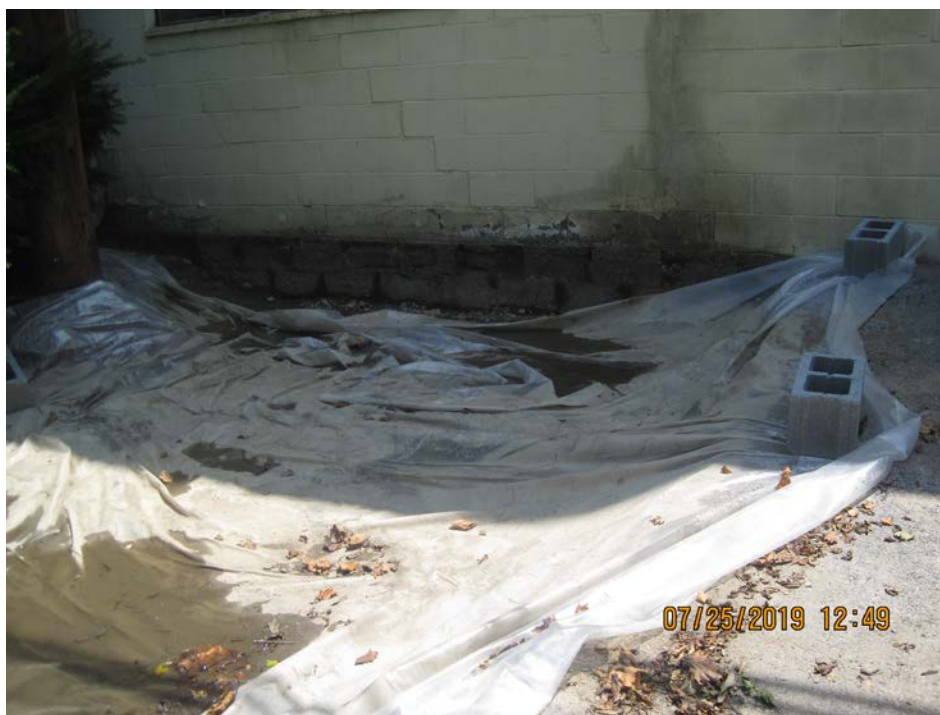
Photograph 13 – View of the exterior release area from the fence

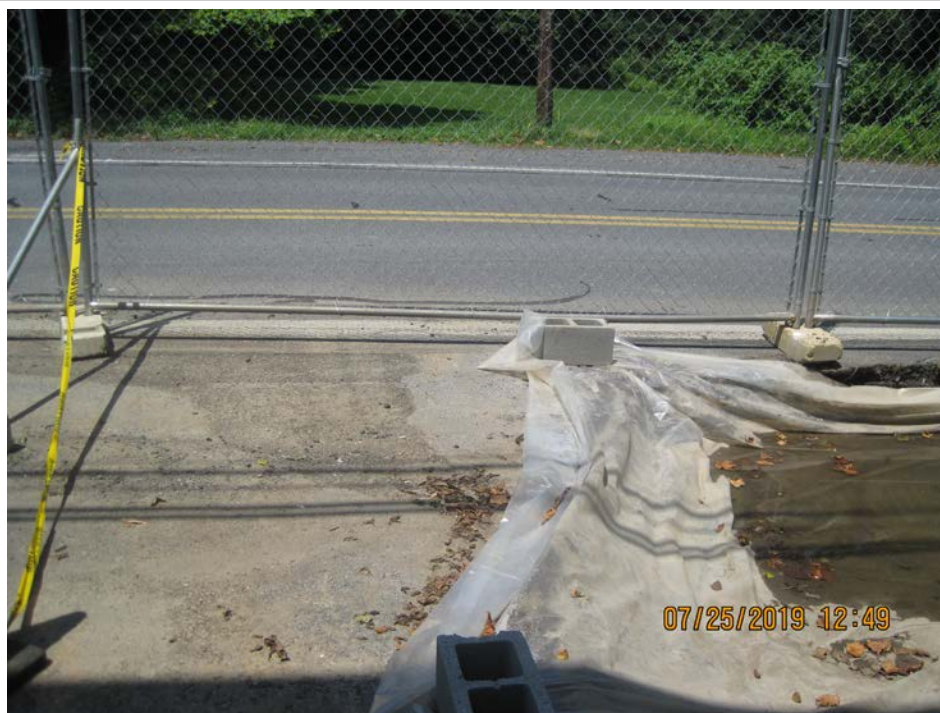
Photograph 14 – View of the exterior release area from the building facing Mohrsville Road

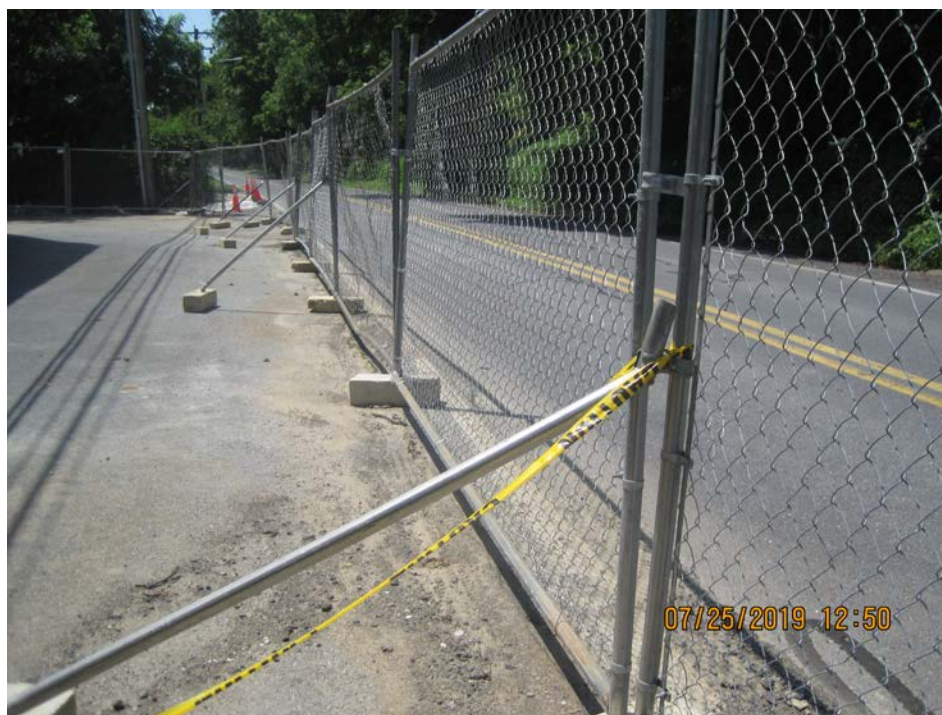
Photograph 15 – View along Mohrsville Road where the release of nitric acid flowed in a southwesterly direction

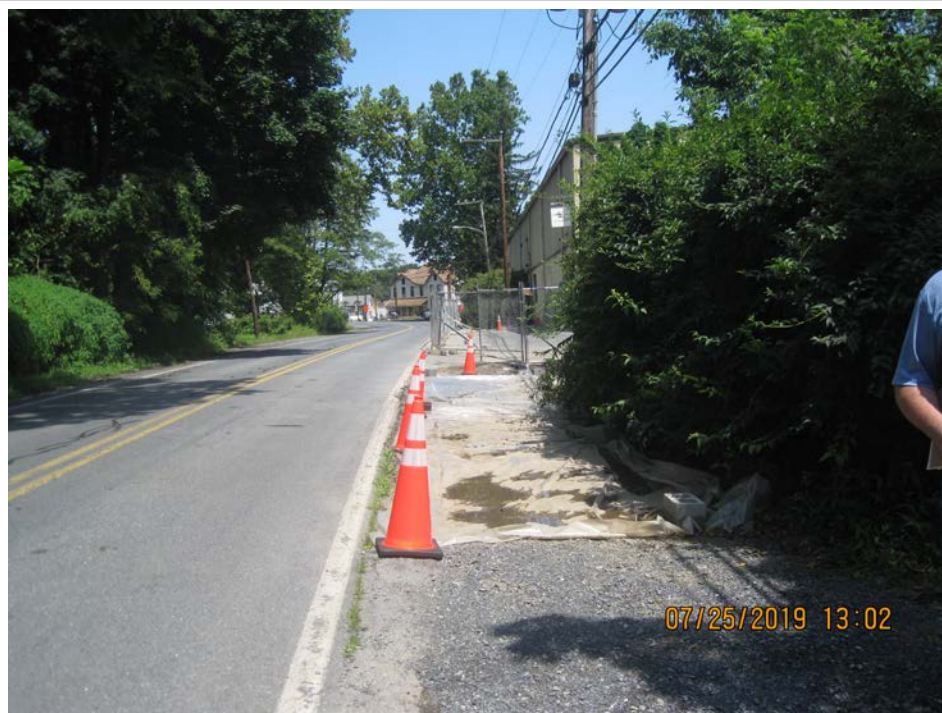
Photograph 16 – Additional view along Mohrsville Road where the release of nitric acid flowed in a southwesterly direction

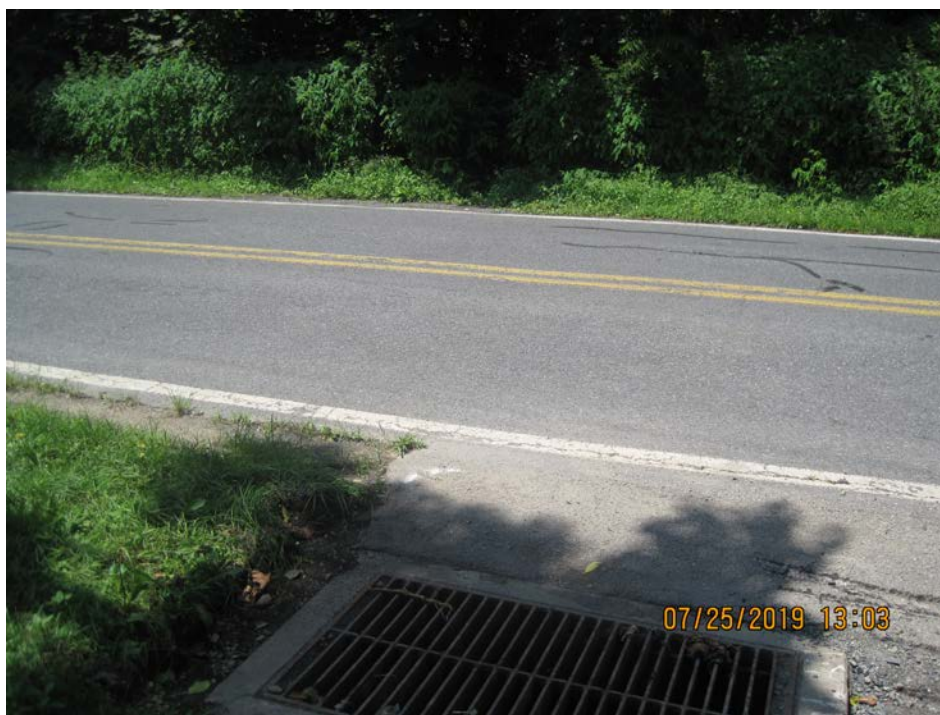
Photograph 17 – View of the storm drain along Mohrsville Road located offsite just southwest of the facility

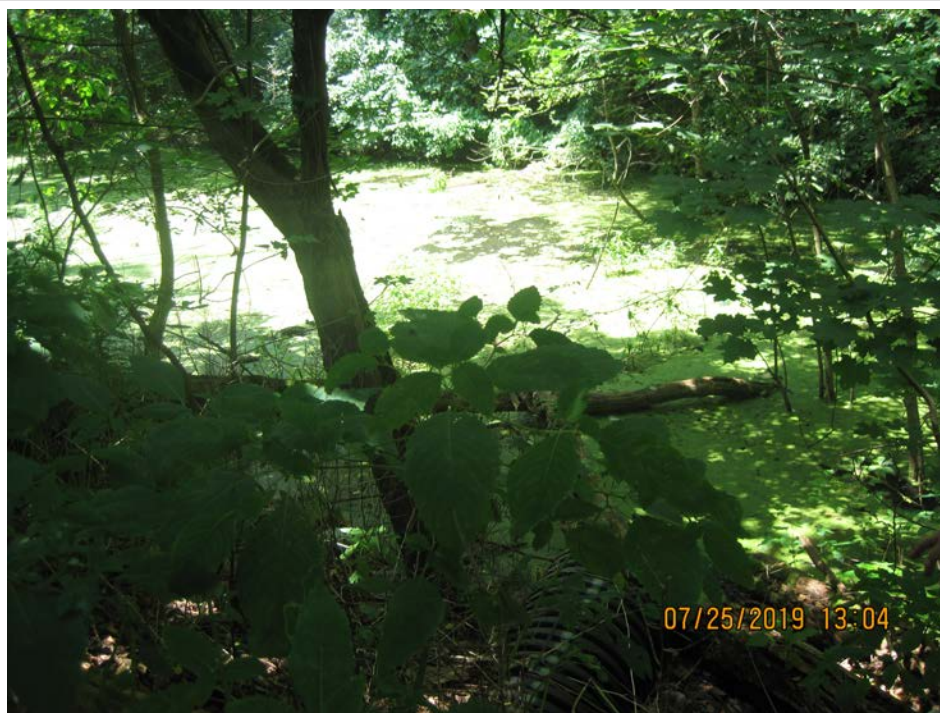
Photograph 18 – View of the outfall from the storm drain located across Mohrsville Road
